# POST-TSUNAMI COASTAL RESOURCE DAMAGE ASSESSMENT

TUTUILA, AMERICAN SAMOA

OCTOBER, 2009

*PREPARED BY THE GOVERNOR'S CORAL REEF ADVISORY GROUP*

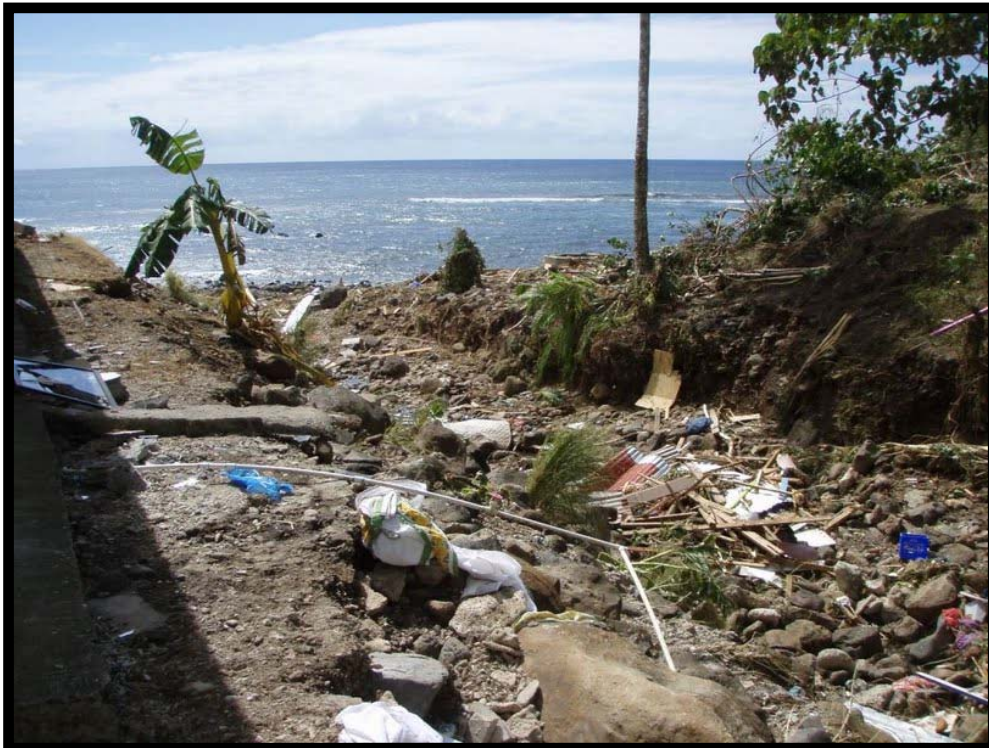
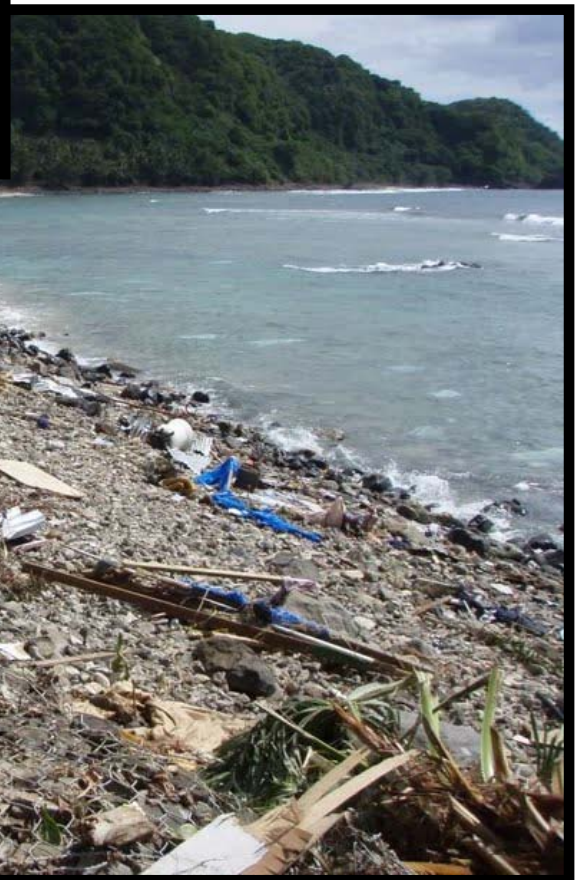
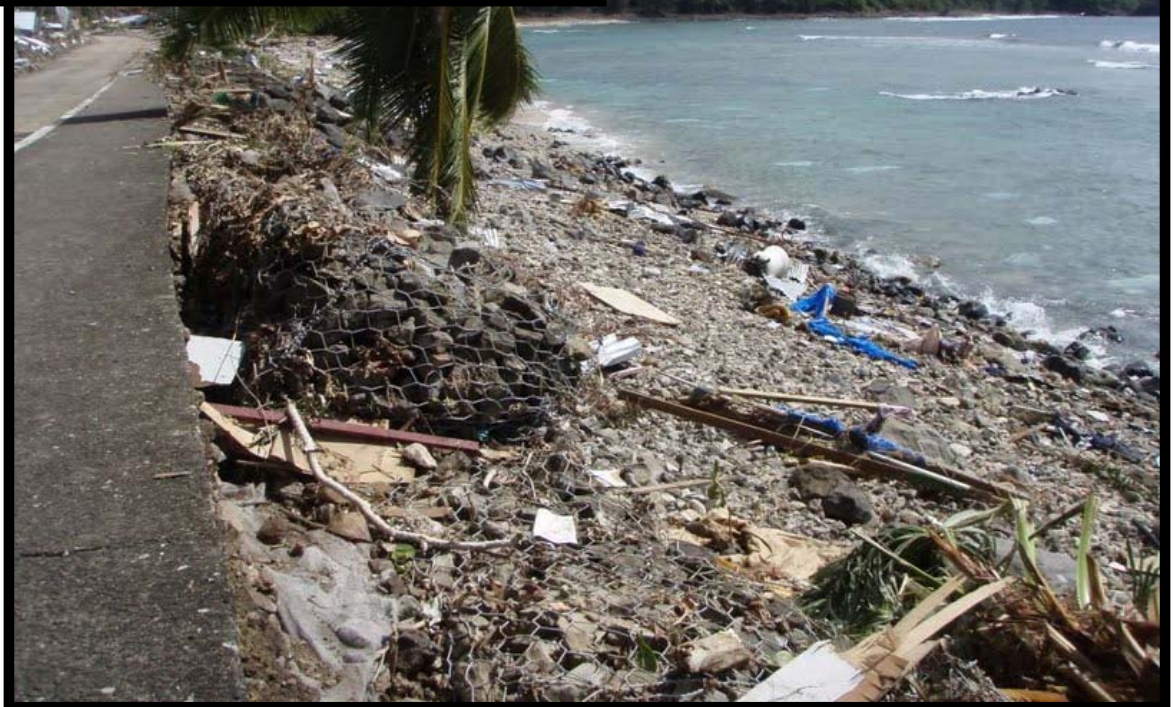
# Poloa

Poloa received a direct impact from the tsunami wave and suffered tremendous destruction. Approximately 90% of buildings were completely destroyed: only one church and one home are left standing. The shoreline along Poloa consists of a high rocky shore along a large open bay. There is a man made seawall in place but this is now damaged and knocked down in certain sections. A reef flat and stream habitat and severe amounts of marine debris present, mostly tin roofs and household good and materials such as refrigerators, mattresses, and tin building material. The approximate inundation level was 300 feet and there is good accessibility. Village homes along shoreline were severely damaged and marine debris on the coastline is extreme. Taro and bananas patches further upland were not impacted. One site has multiple cars leaking fluids.

Marine debris scale: 4

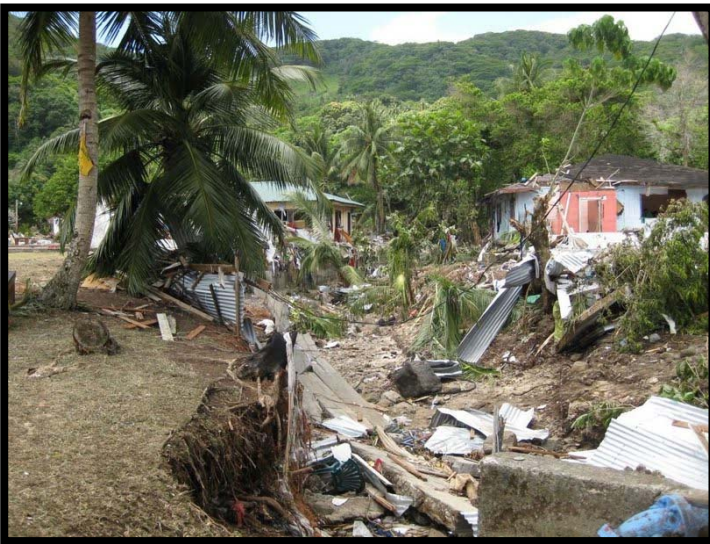
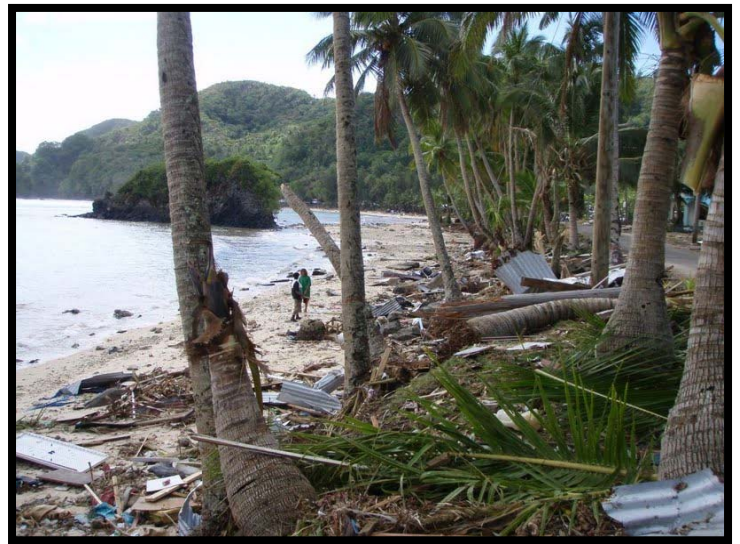
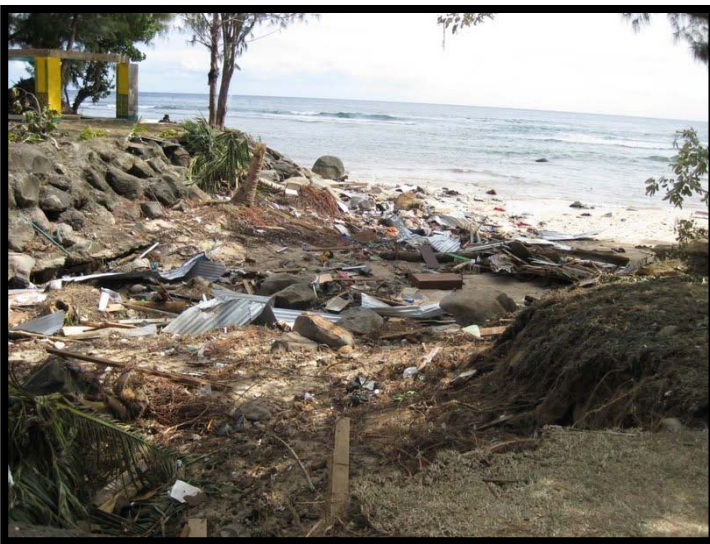
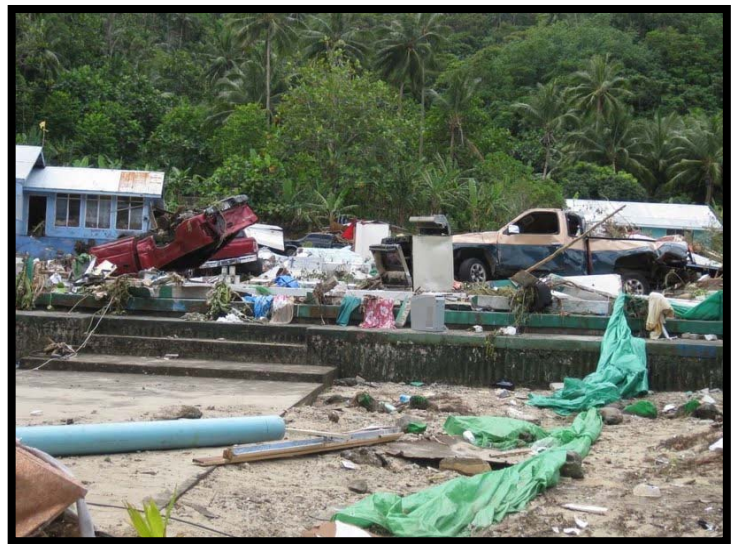
# Amanave

The shoreline along Amanave consists of a sandy bay/cove which is relatively exposed to ocean conditions. A manmade seawall exists in front of the village. The main habitat type is a reef flat and a sediment plume was present approximately 30 ft in the center of the bay next to outcropping. Marine debris is severe in places but several pieces were stopped from entering the ocean due to a line of trees between the village and the water. A severe amount of marine debris is visible on the reef including one vehicle. Coastal debris is mostly household goods, plastic tables, chairs, roofing, wood, and other miscellaneous small items. The inundation is approximately 1,000 feet and there is good accessibility to the coastline. Vegetation up to 30 feet along the sides of the bay is cleared. It is unclear how much erosion is due to the event but there is a steep drop from the tree line down to the beach. Banana trees were wiped out on western edge of the village and there is a bus in vegetation on eastern side of the bay. Numerous refrigerators and air conditioning units were on the beach, and several cesspools and at least six septic tanks were damaged.

Marine Debris Scale: 5

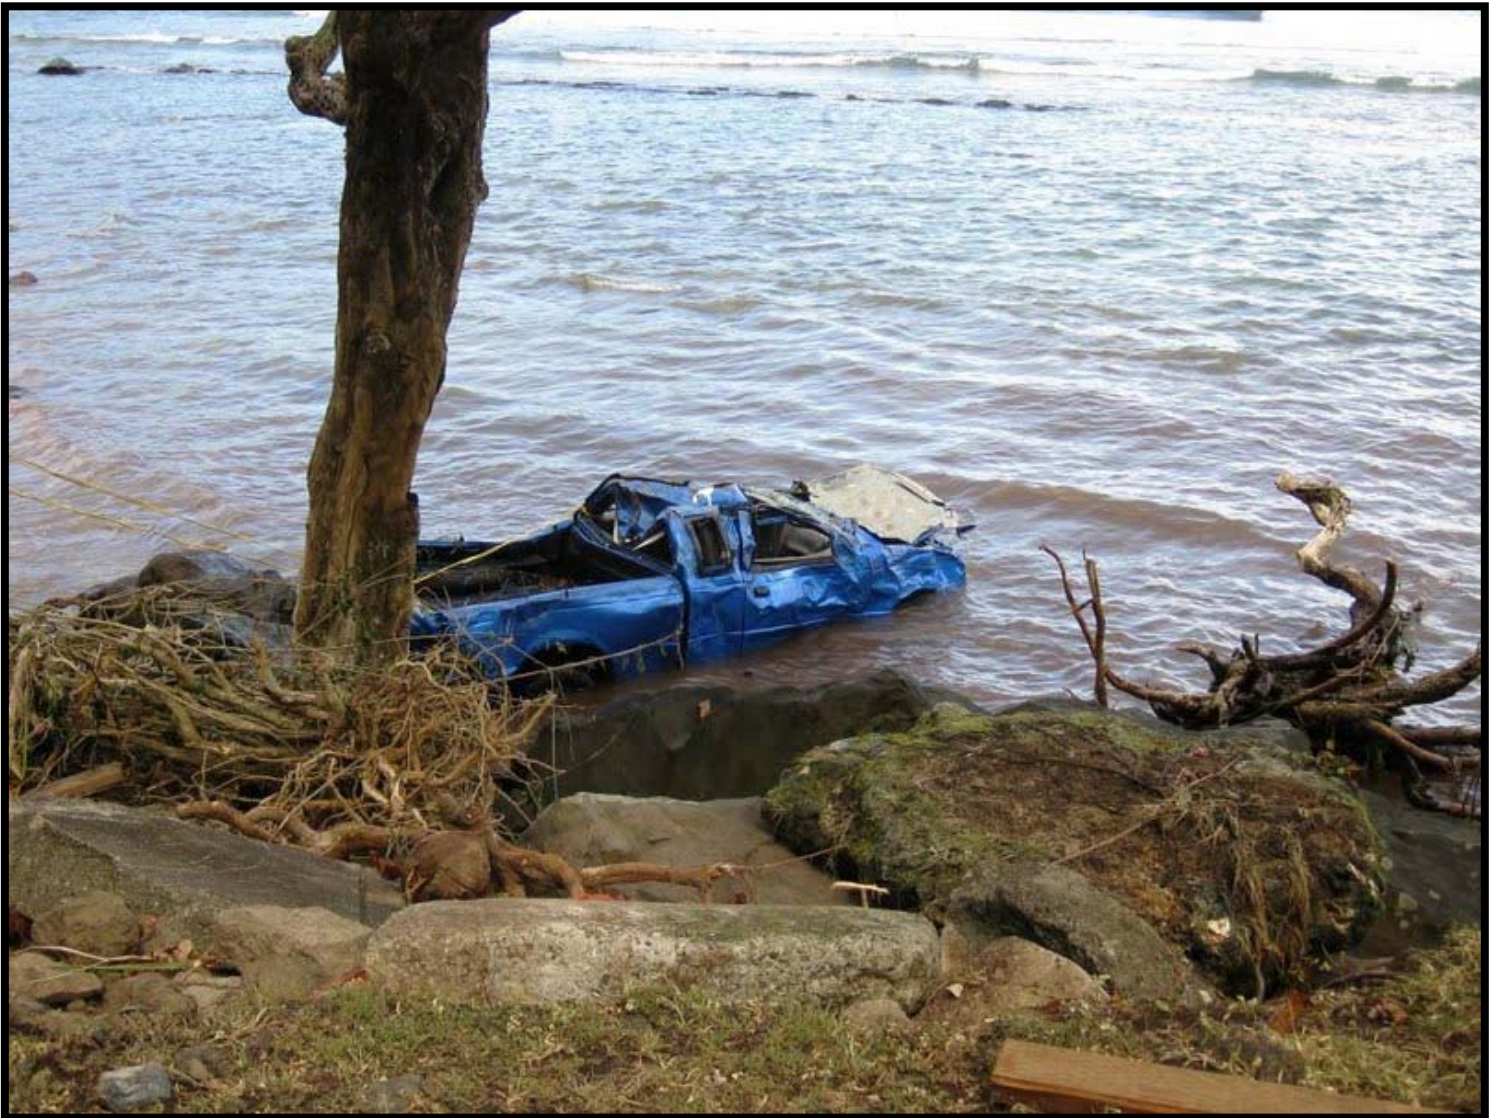
# Fa'ilolo

The rocky shoreline and sandy beach along Fa'ilolo are very exposed to the open ocean conditions. The dominant coastal habitat is a reef flat and a 20 foot wide sediment plume was seen along the shoreline. Coastal debris is patchy and consists mostly of small items (tin, bottles, cans, etc...). The debris appears to be concentrated along the eastern end of the bay, and marine debris appears to seem less than in other villages. However, there is a vehicle in the water which may be leaching contaminants. The inundation is approximately 100 feet and landslides on the eastern end of the bay are visible.

Marine Debris Scale: 2

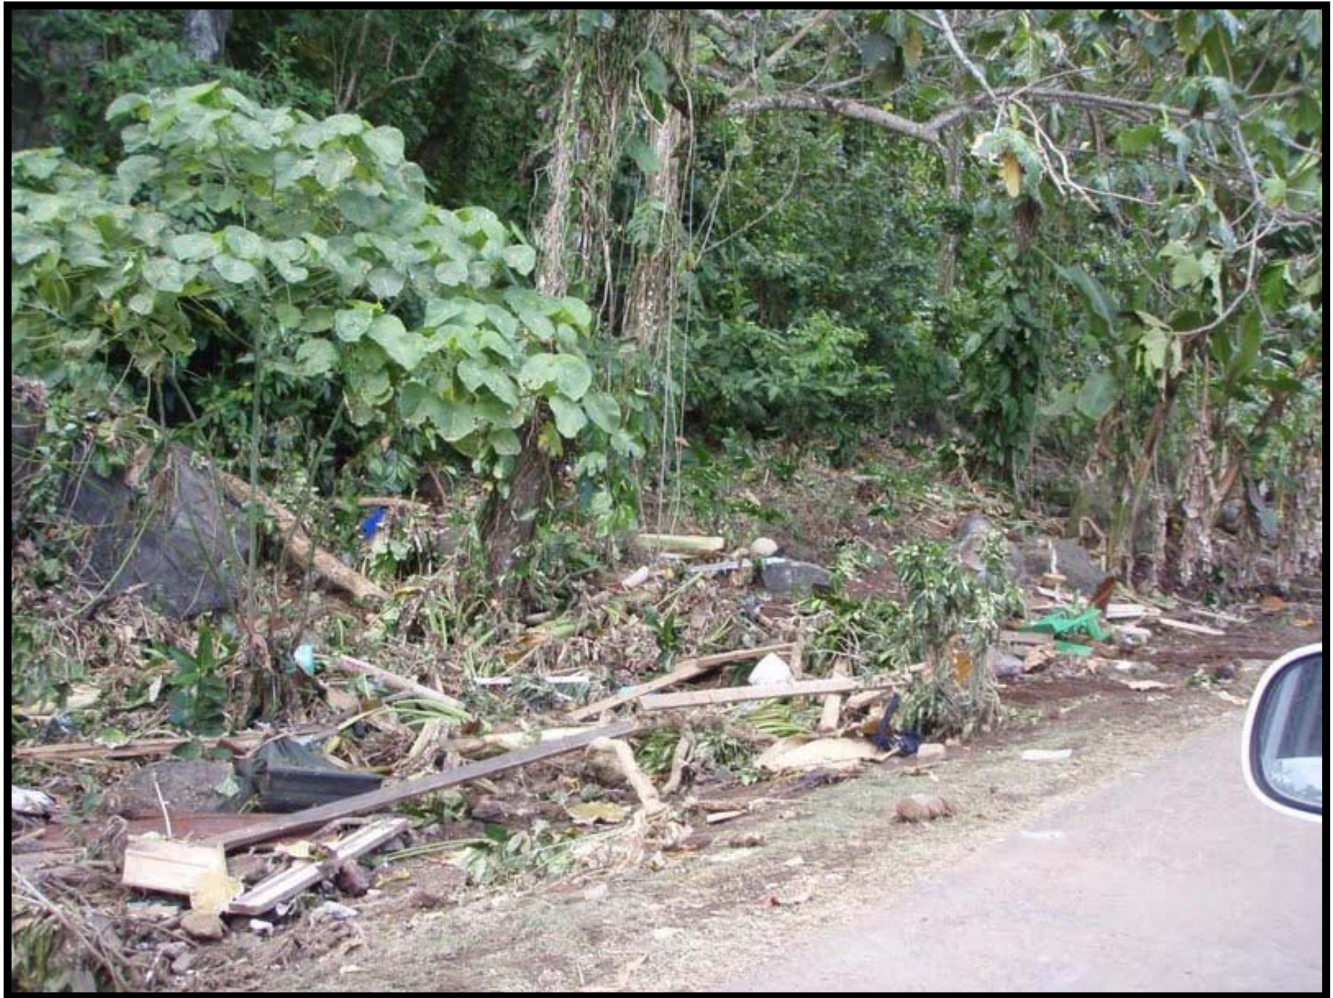
# Agugulu

A rocky shore and sandy beach make way for a large reef flat along the village of Agugulu. There is a man made seawall and marine debris is concentrated in patches along the western end of the bay. The approximate inundation level is 60 feet, there is good accessibility to the site, and a small amount of property damage is visible.

Marine Debris Scale: 2.5

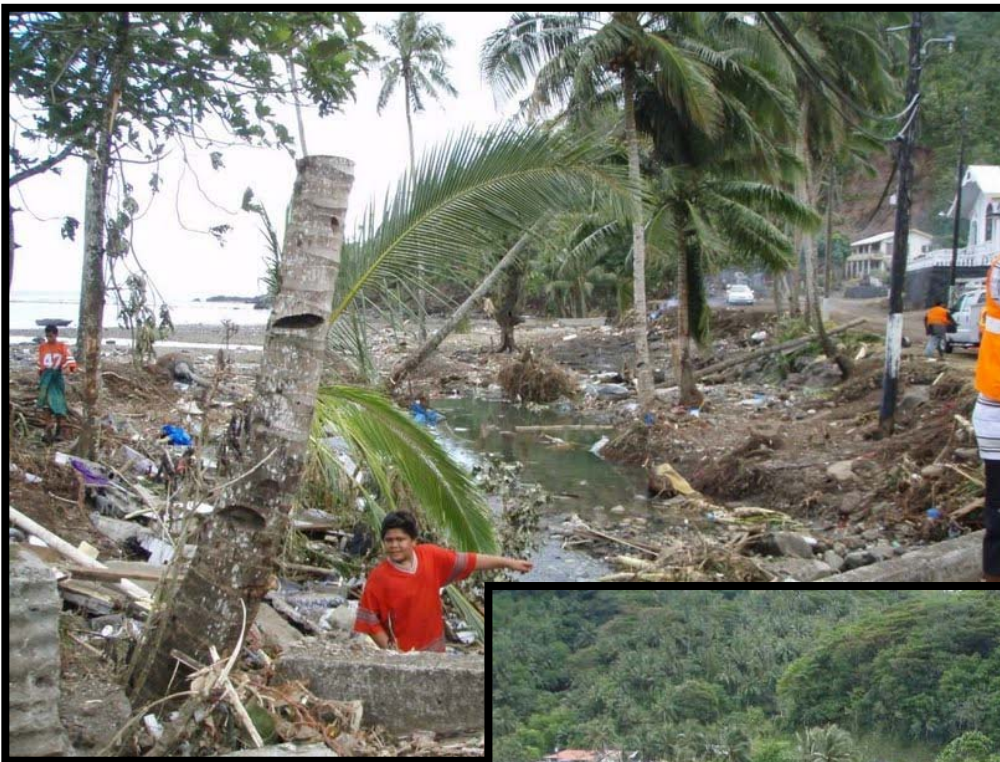
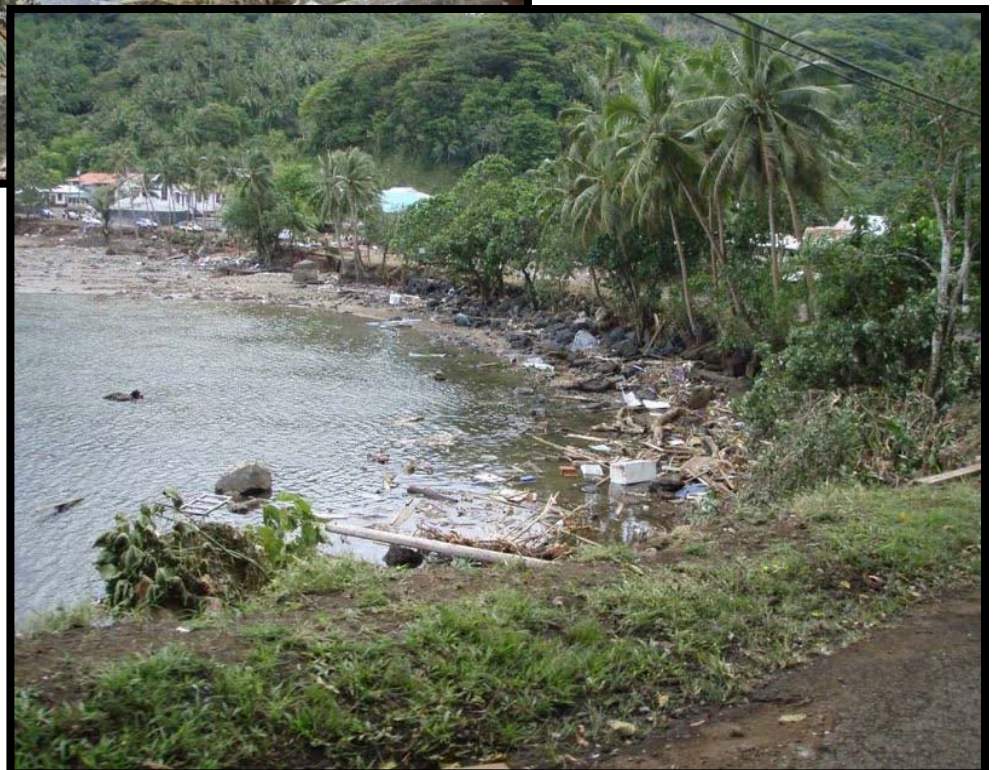
# Asili

A steep 15 foot embankment gives way to a small protected rocky beach and a substantial stream system along Asili. Shoreline erosion is present and a reef flat exists just offshore. The debris appears to be concentrated on the eastern end of the bay and consists of mostly household goods and building materials. There is extensive debris in the stream mouth, including multiple vehicles leaking fluids, and a significant amount along the shore. There is good site accessibility and the inundation level is approximately 1,000 feet. There is damage throughout the village and there are piles of debris everywhere. Multiple septic tanks and cesspools were damaged and there is a large amount of debris resting in standing water under the bridge.

Marine Debris Scale: 5

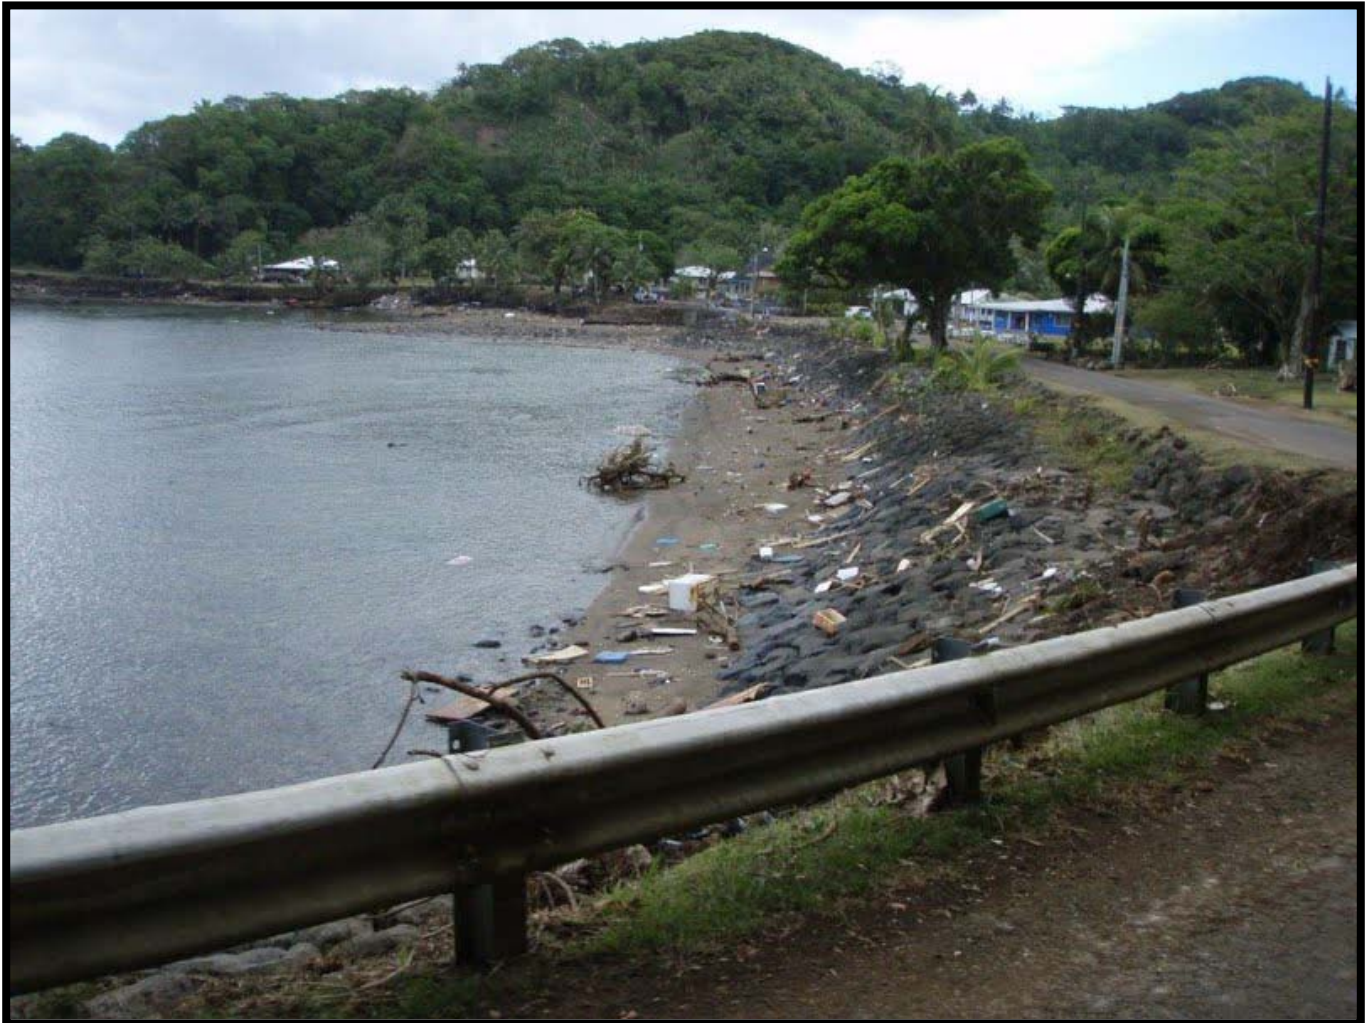
# Amaluia

Amaluia has a rocky shoreline with a relatively steep embankment, a man made seawall and a fairly large stream drainage. A reef flat exists just offshore and a sediment plume approximately 10 feet wide was visible. Debris appeared to be concentrated on the east end of the bay and there was a tremendous amount of debris in the stream. The inundation level is approximately 100 feet and there is good accessibility along a steep embankment. Several cesspools are damaged and approximately 3-5 septic tanks ruptured.

Marine Debris Scale: 4

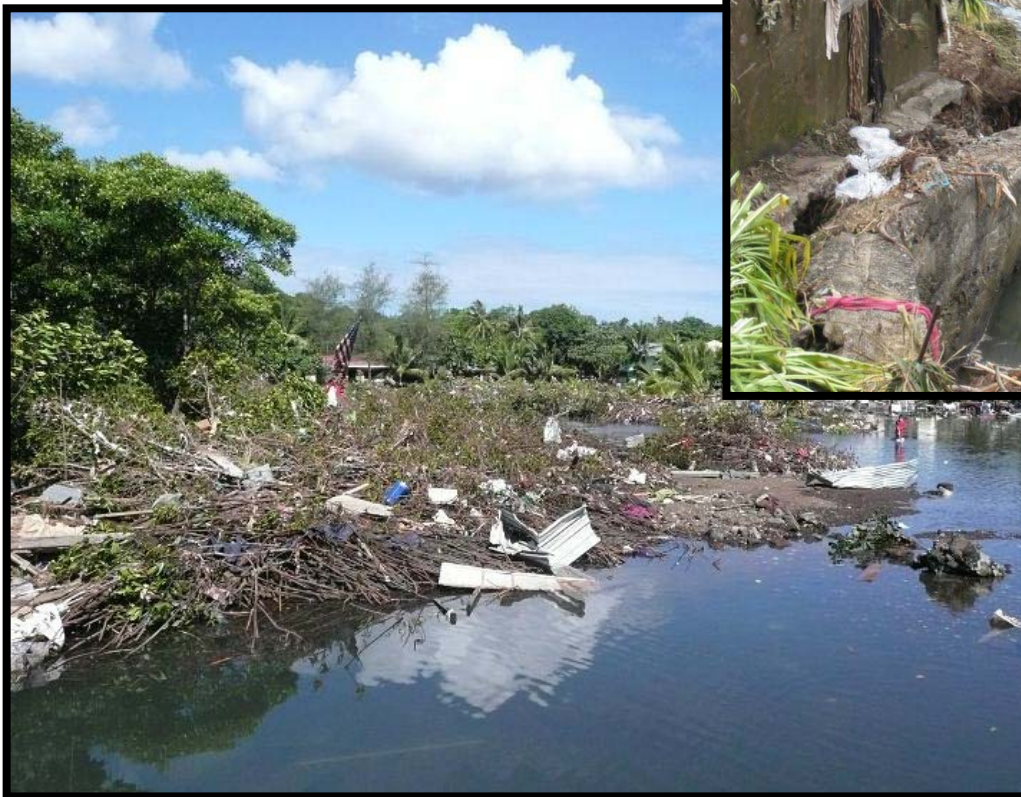
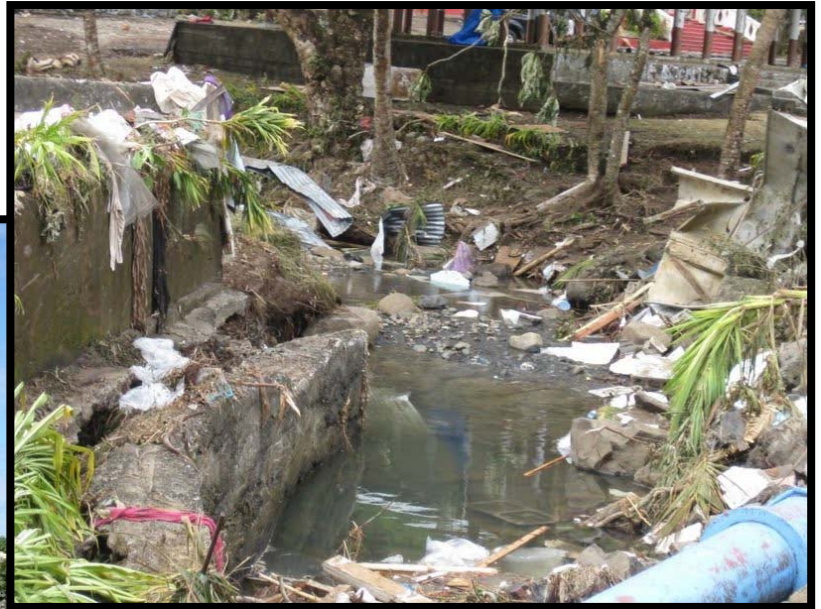
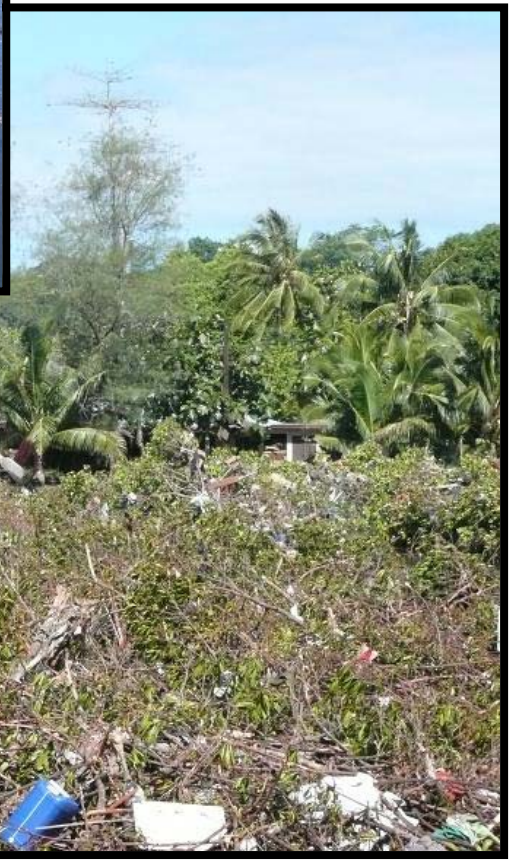
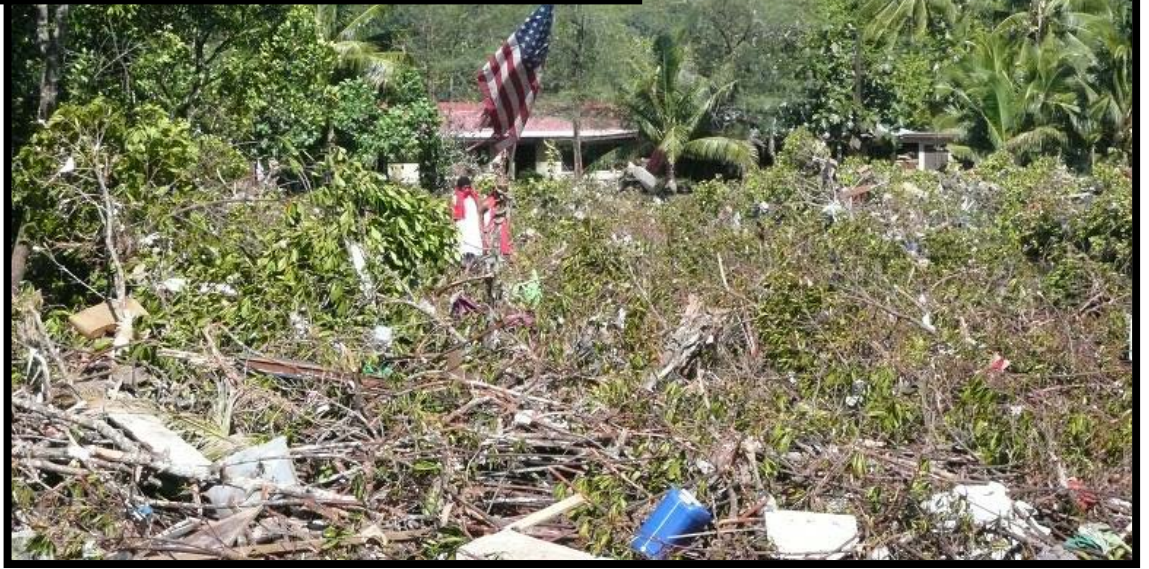
# Leone

Leone has one of the few remaining extensive mangrove lagoons on the island as well as a reef flat just offshore. It received a direct impact from the tsunami and is one of the most devastated villages on Tutuila. There are extensive piles of debris immediately adjacent to the shoreline. The wetland area is entirely covered with debris yet the shoreline debris is patchy and not as severe. The inundation is at least 1,000 feet. The shore has a shallow embankment and is easily accessible. However, the wetland is behind the destroyed village and is now difficult to access. Multiple damaged vehicles are leaking fluids, a damaged gas station may be leaking fuel, and there are several damaged and exposed cesspools and septic tanks.

Marine Debris Scale: 5

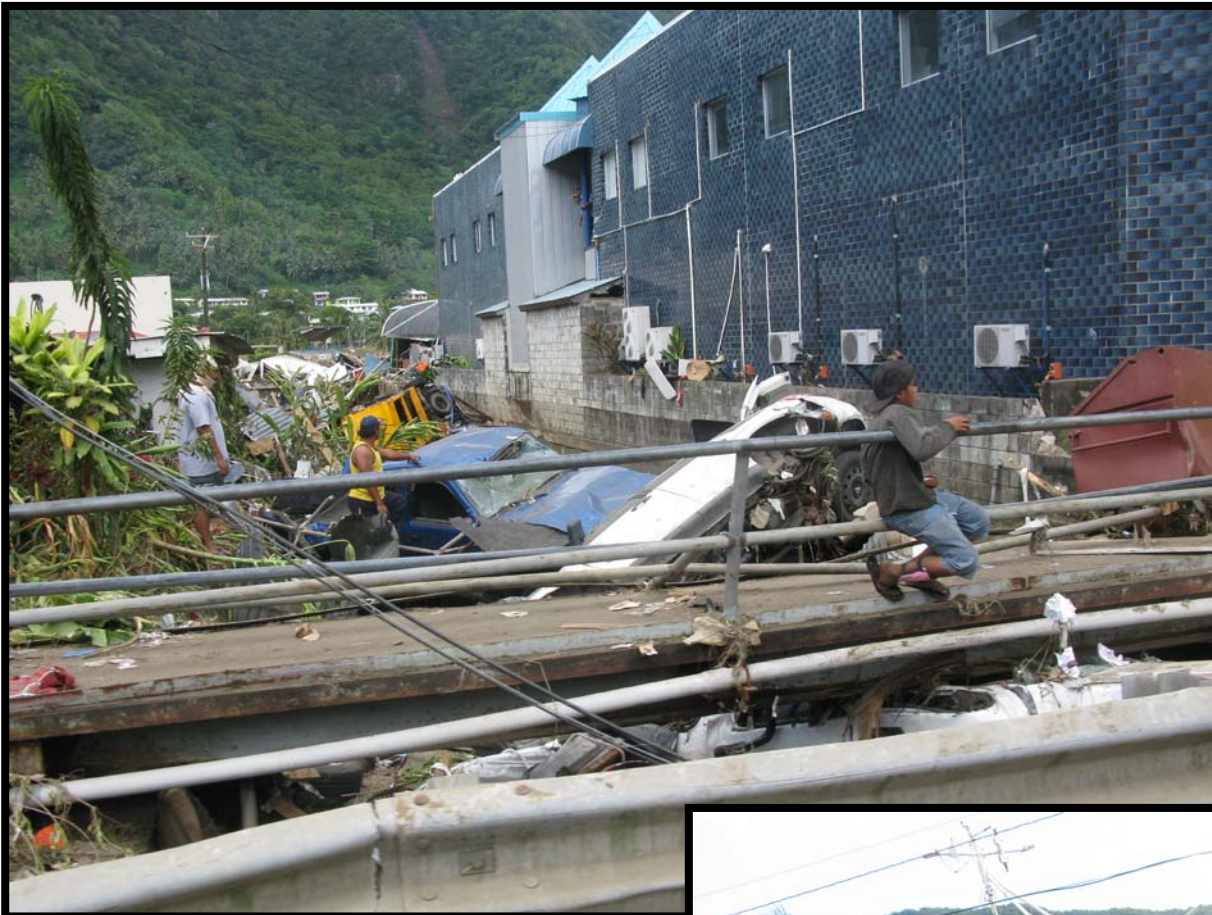
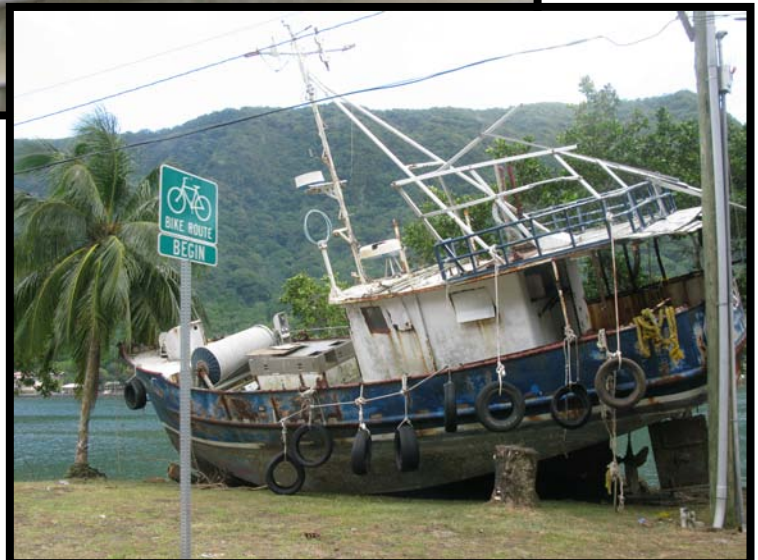
# Pago Pago

Pago Pago was ground zero for the tsunami and received the most significant large scale damage in American Samoa. Entire buildings were completely destroyed, buses were flipped over, boats were lifted onto the roads, and cars and debris entirely fill several streams. The inner section of Pago Pago Harbor is severely polluted and will require an extensive clean up program with a significant amount of man power. The destruction is everywhere. An oil spill approximately 40 feet in width was seen in the mouth of the harbor and fuel drums were seen washed up along shore. Approximately one dozen cars have been destroyed and are leaking fluids. Several air conditioning units were damaged and may be leaking. There is undoubtedly a significant amount of debris that washed into the harbor and water quality is severely impaired.

Marine Debris Scale: 5

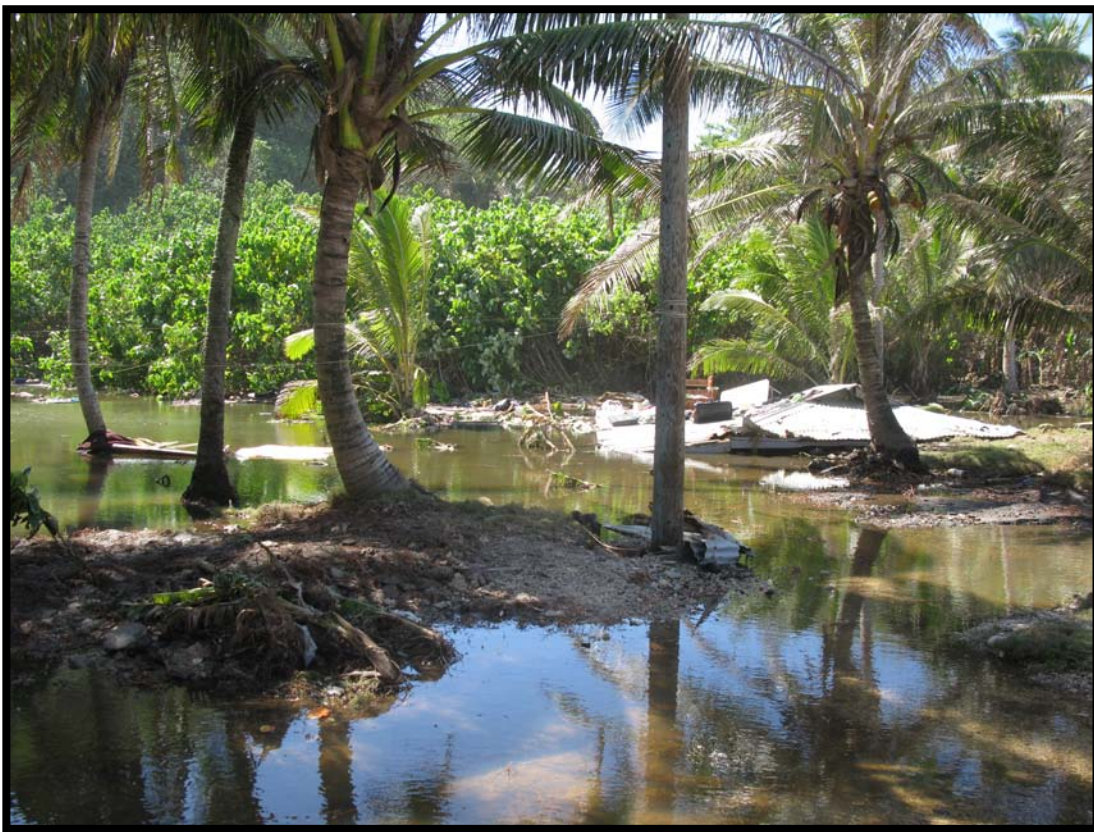
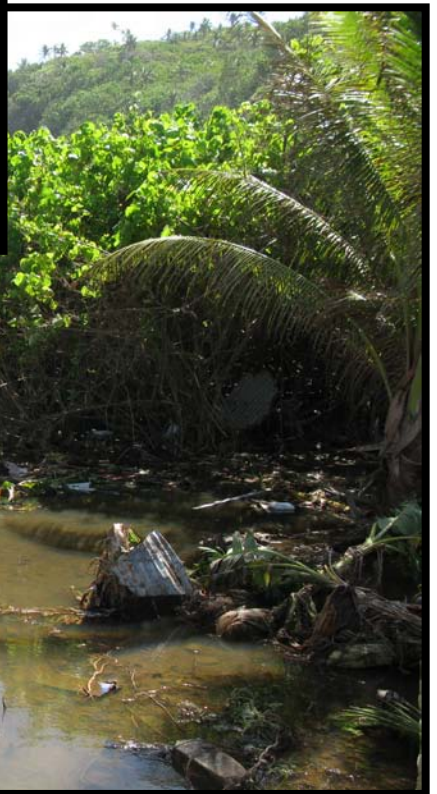
# Alao

Alao has experienced significant damage which, although not as physically devastating to the homes as Leone or Tula, may significantly impact the environment and community as well. The slope of the main road has caused seawater to remain standing behind the surrounding homes closer to the wetlands, approximately 500 feet inland. Trash is floating on the water and a number of the homes have experienced broken septic tanks (GPS: 0547193x8423542 (#15), 0547215x8423516 (#16 – 2 septic breaks), 0547191x8423468 (#17), 0547165x8423434 (#18), and 0547137x8423416 (#19)). Several of the broken tanks appear to have leaked and there is a large number of dead fish in the water. The wetlands behind the village were inaccessible due to the standing water but it would appear that the wetlands are being moderately to severely impacted by the standing, polluted water. For future communication with Alao, the mayor is very particular that he be contacted. His name is Moses and he can be reached at: 252.0077.

Marine Debris Scale: 4

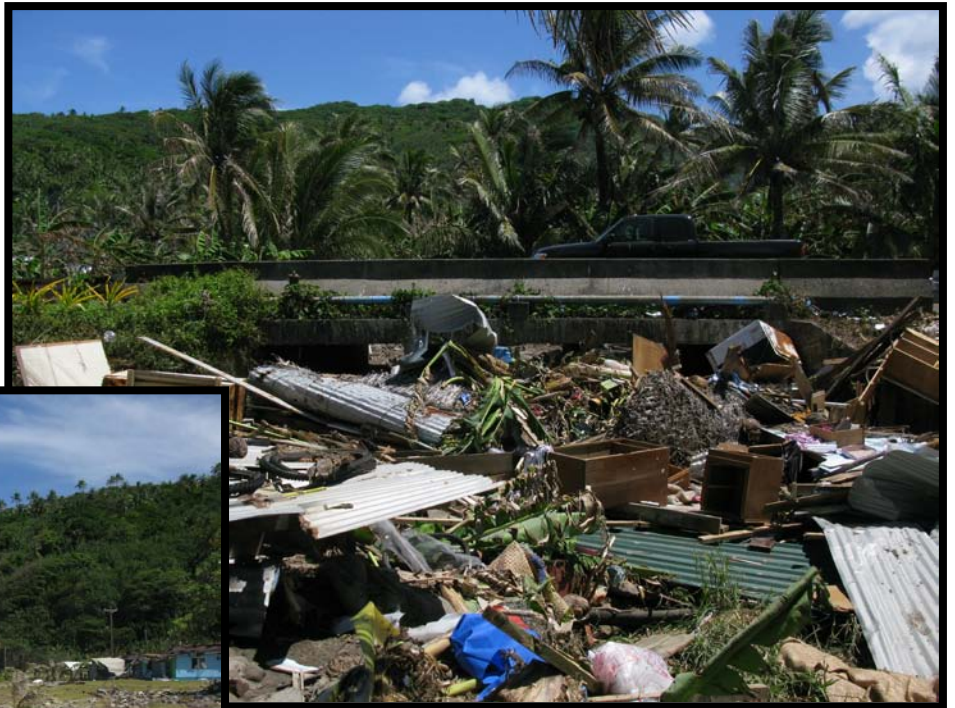
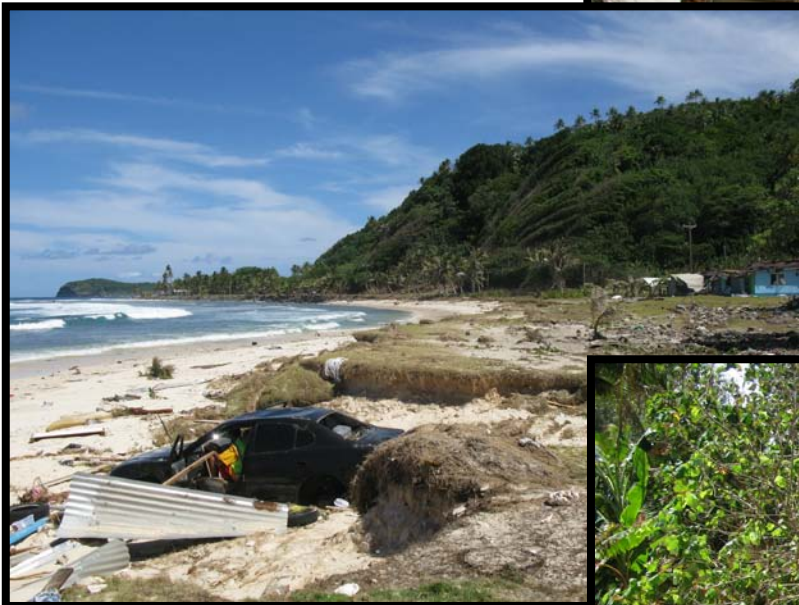
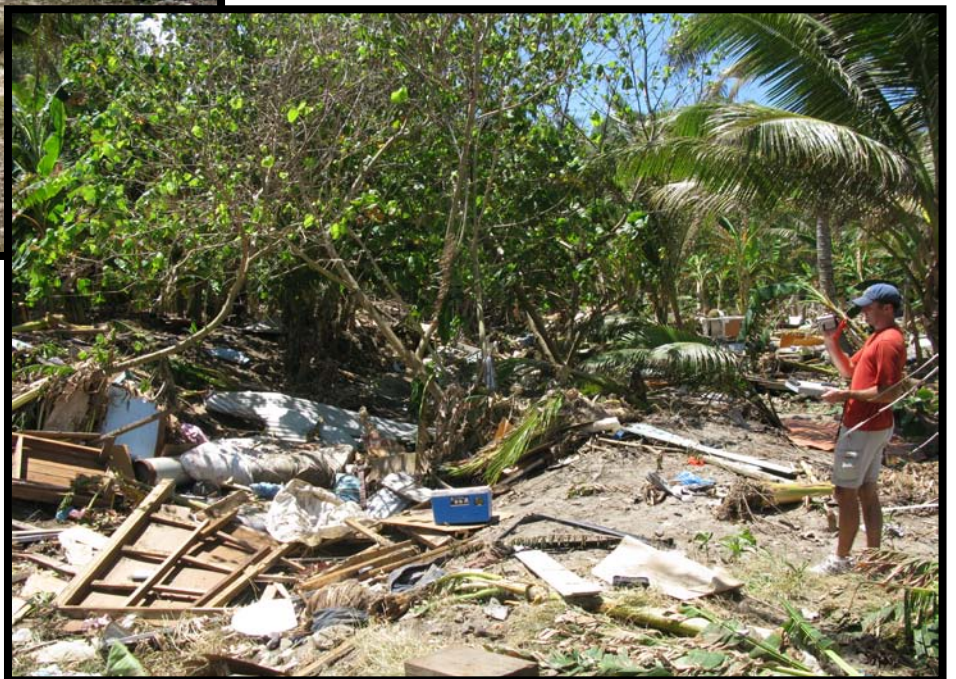
# Tula

Parts of Tula village were completely decimated by the tsunami and there are collapsed homes and debris over the entire village grounds. The majority of the debris are home effects, such as beds, clothes, electronics, and parts of the building structure. The mangroves and wetlands cover an extensive area and appear to have sustained moderate damage and the stream separating the wetlands/mangroves from the village is completely clogged with large debris including building materials, tin roofs, cabinets, etc... Several car batteries were seen along the stream area. The coastal debris is more sparse and mainly includes smaller items. However, the close proximity to the reef flat indicates a high probability that significant amounts of debris washed out onto the coral reef. There is also a car on the beach that may be leaking hazardous fluids (GPS: 0546992x8424168; #14). There were also a number of broken septic tanks although none appeared to be leaking (GPS: 0546913x8424426 (#10), 0546894x8424422 (#11), and 0546934x8424468 (#12 – there is a propane tank here as well)). There is good access to this site and inundation levels are approximately 700 feet.

Marine Debris Scale: 5
