## UNESCO-IOC International Tsunami Survey Team Samoa (ITST Samoa)

### Interim Report of Field Survey 14<sup>th</sup> – 21<sup>st</sup> October 2009

**Australian Tsunami Research Centre Miscellaneous Report No. 2:  
October 2009**

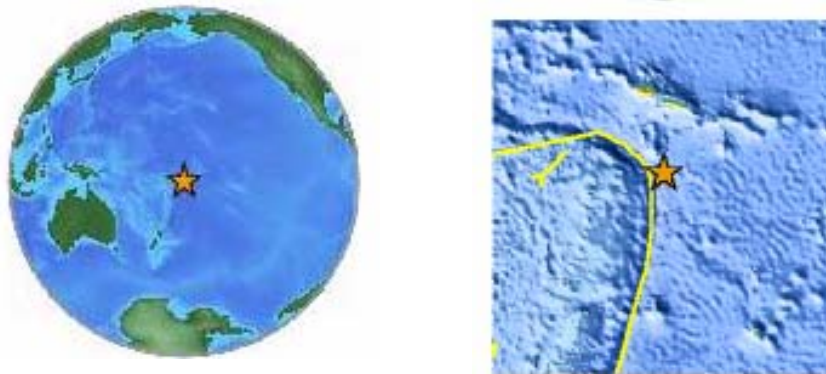
**Figure 1** The earthquake epicentre (Source: USGS)

On the basis of currently available location and fault mechanism information, United States Geological Survey (USGS) suggested that the earthquake occurred as a normal fault rupture near the outer rise of the subducting Pacific plate, while the DART buoys (tsunami detection buoys) suggest the possibility of a reversed fault. The earthquake parameters based on USGS data located the hypocentre at a depth of 10 km, with dip, strike and slip of 52°, 345°, and –61°, respectively.

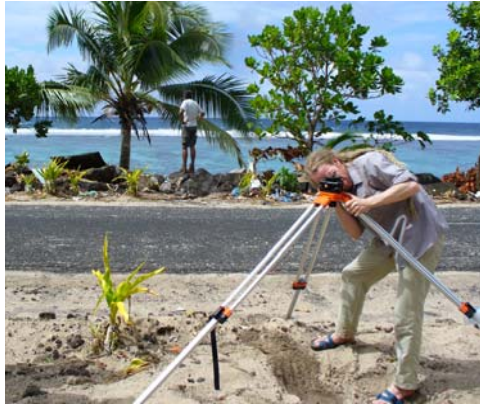
The RTK GPS requires good satellite coverage to deliver accurate results. However, satellite reception in densely vegetated areas is limited. Hence, it was decided to use precise levelling with a level and scaled staff (Figure 5) as an additional tool to survey topographic profiles as well as inundation distances and depth.

**Figure 4: Setting up the RTK GPS base station**

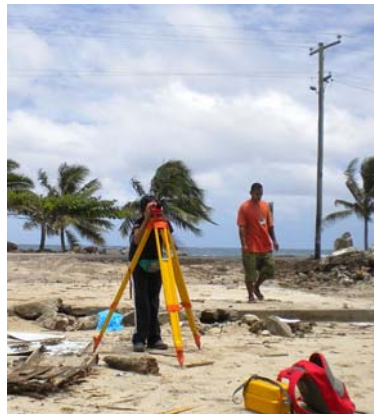
**Figure 5: Levelling to obtain ground profiles**

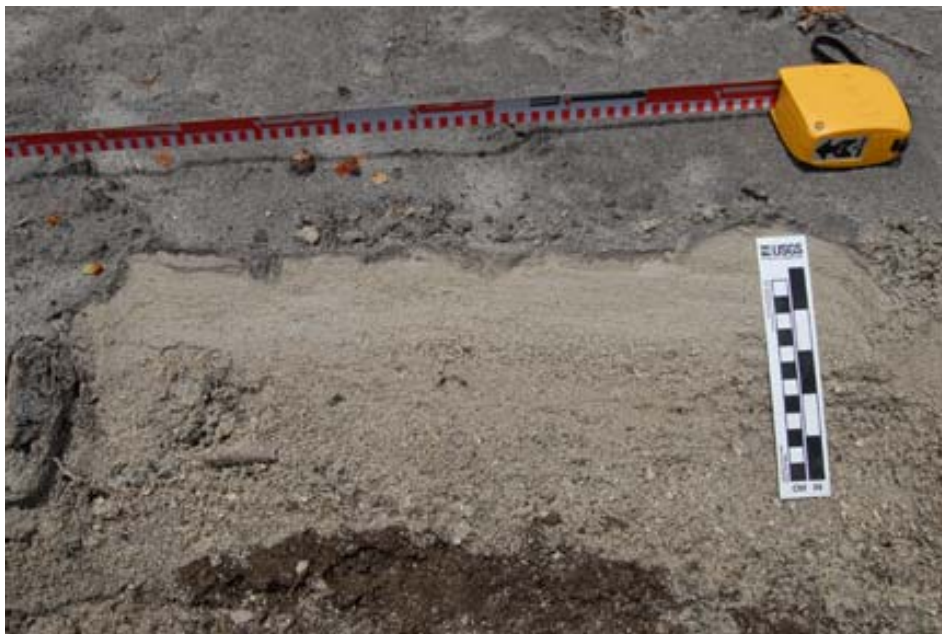
**Figure 6: Shallow trench from Satittoa, on the east coast showing pre-tsunami soil at base with sharp contact to overlying tsunami sand with multiple laminations and capped by a thin mud drape**

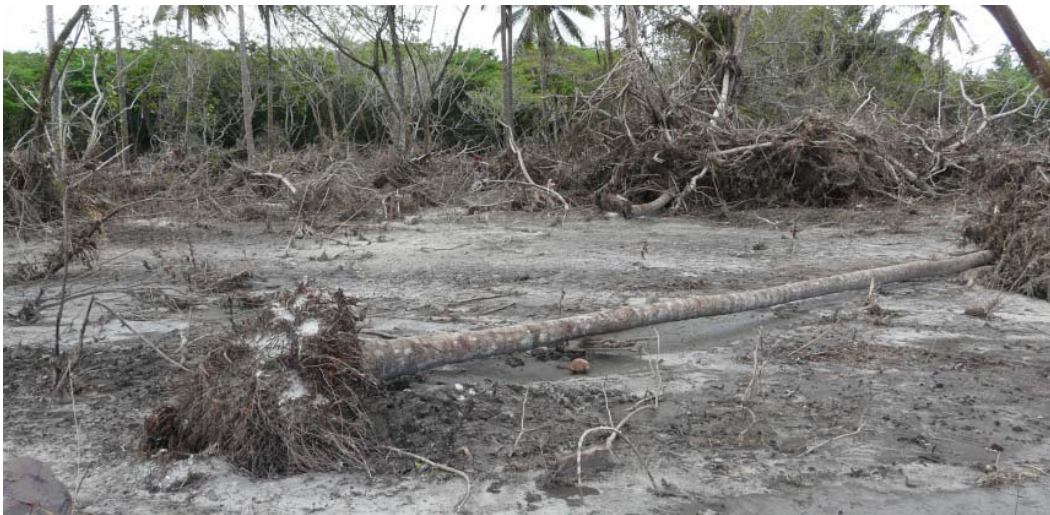
(1) *Flow direction* was recorded from a number of field observations and measured by compass (either magnetic or GPS), alignment of bent vegetation (palm trees or coconut trees; Figure 7), alignment of collapsed building structures (*fale* pillars or water pipes), alignment of fence posts anchored on the seaside walls of some partially destroyed building, and material such as metal roofing wrapped around tree trunks.

**Figure 7: Coconut tree trunk used as a flow-direction indicator**

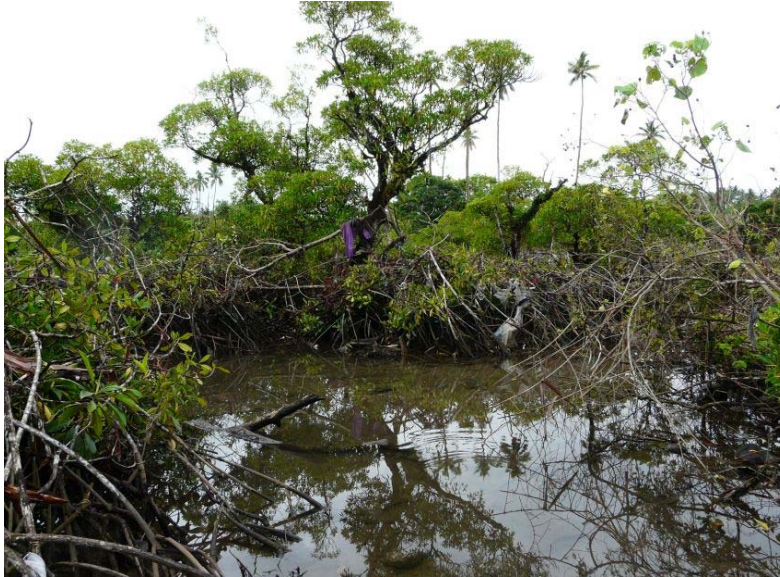
(2) *Flow depth* was measured with a laser range finder using field evidence such as scratched tree trunks, bark removal, broken branches, rubbish trapped in branches etc (Figure 8).

**Figure 8: Clothes in a mangrove tree at Vaovai used as evidence for measuring minimum flow depth**

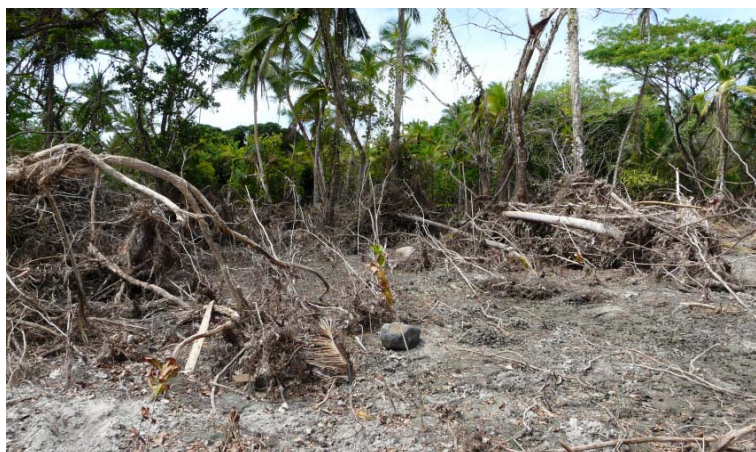
Delineation of inundation was made using GPS measurements at the marine water inundation limit. Marine inundation can be recognised in the field by observing the contact between salt-burnt yellow grass and non-flooded green grass, limit of debris wrack line, and eyewitness accounts (Figure 9).

**Figure 9: Vegetation debris rampart composed mostly of tree trunks and branches at Satitua**

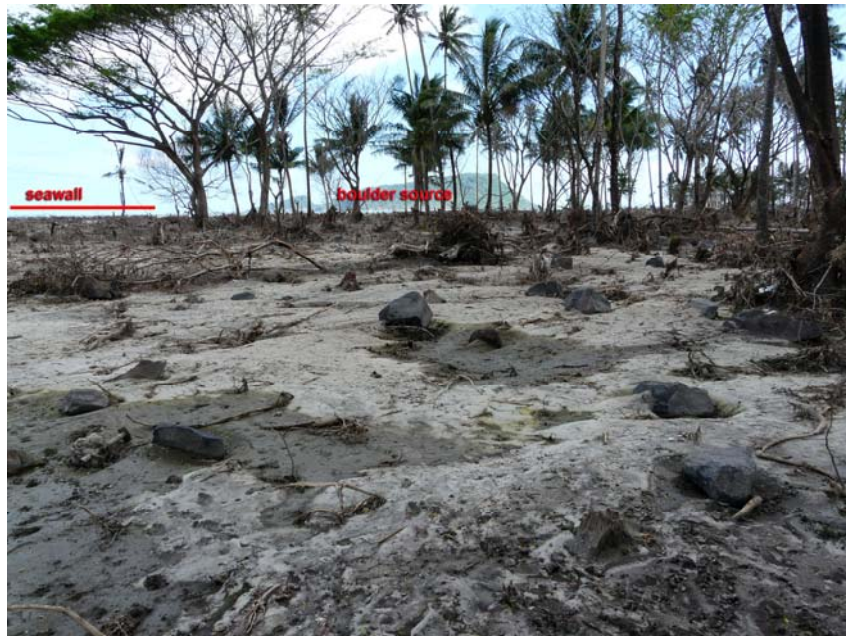
A boulder field of particular interest was investigated in Satitua (Figure 10). Boulder granulometry was recorded along both transverse and longitudinal profiles, according to field evidence of the tsunami primary flow direction in this area (N340 to N010): *A*, *B*, *C* axes and long-axis orientation were measured. A waypoint was recorded for each measured boulder. We assumed that the damaged seawall along the coast road was the source for the boulders. A few small rounded boulders were encountered in the field, but were rejected from the collection as they are not the usual material used in seawall engineered structures. They may come from some “marae” encountered in the surveyed area and partially damaged by the tsunami. One hundred and sixty (160) boulders were measured in this location.

**Figure 10: Boulder field and sand sheet at Satitua. In the background, the seawall behaved as a source for boulders**

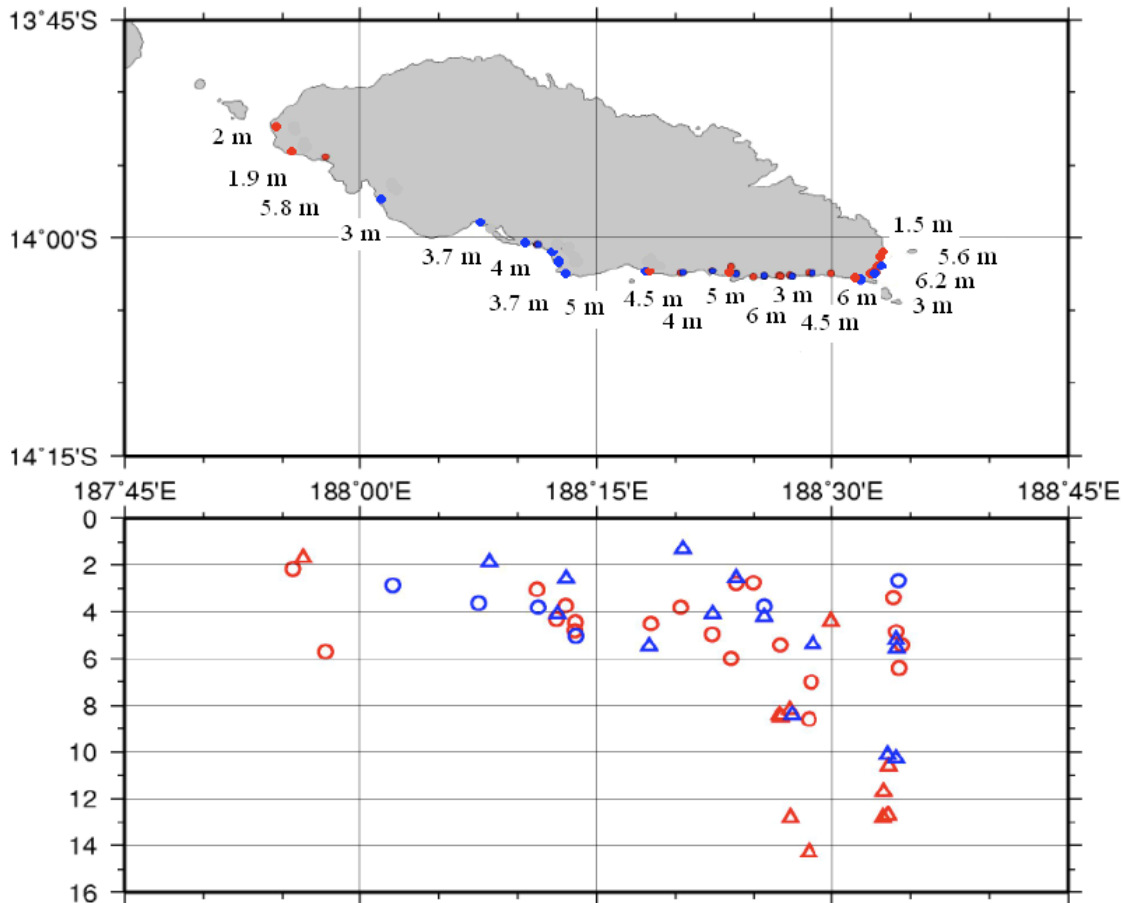
The finer-scale variability in run-up, flow depths and inundation distances reflect site specific influences of nearshore bathymetry (reef morphology), coastal topography and the existence of offshore islands. Some topographic profiles are shown in Appendix 5. Further topographic profiles will be processed in future.

Figure 13: Run-up (blue and red triangle) and flow depth distribution close to the beach (red and blue circle, and numerals on figures above), shows the tsunami characteristics at the coast are very site specific and strongly influenced by the nearshore bathymetry and coastal topography as well as the existence of the offshore islands. Maximum flow depth of up to 8 m occurred at Vaigalu and Vaovau beach at South coast, and 6.2 m at Satittoa. The maximum run up of 14.3 m occurred at Vaigalu. These results are preliminary as the heights are not yet calibrated to the tidal cycles during the measurement period

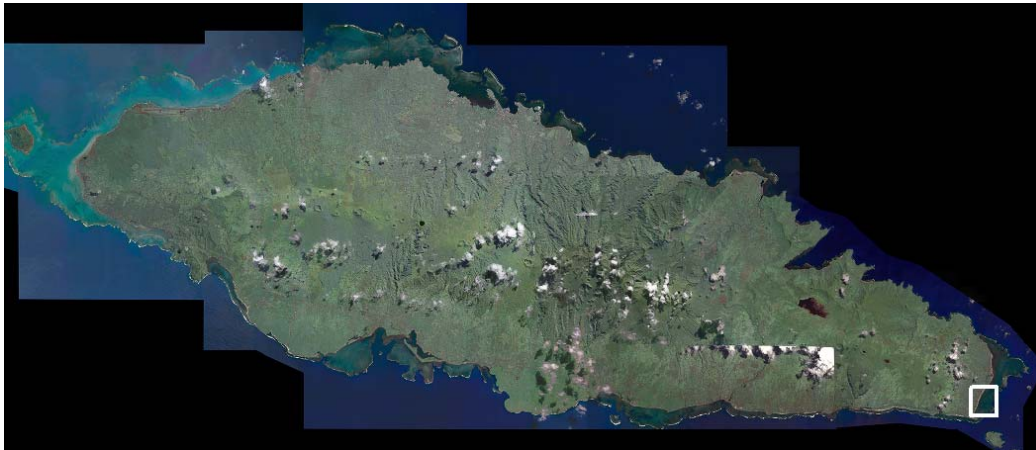
**Figure 18: Location of Ulutogia and Satitooa**

Ulutogia and Satitooa are villages at the Southern end of the east coast of Upolu (Figure 18). Both villages lie in a flat area with a steep hill about 300m inland from the road. The road runs parallel to the beach and parts of the coastline were protected by a rock seawall. The settlement area covered the area between the road and the hill.

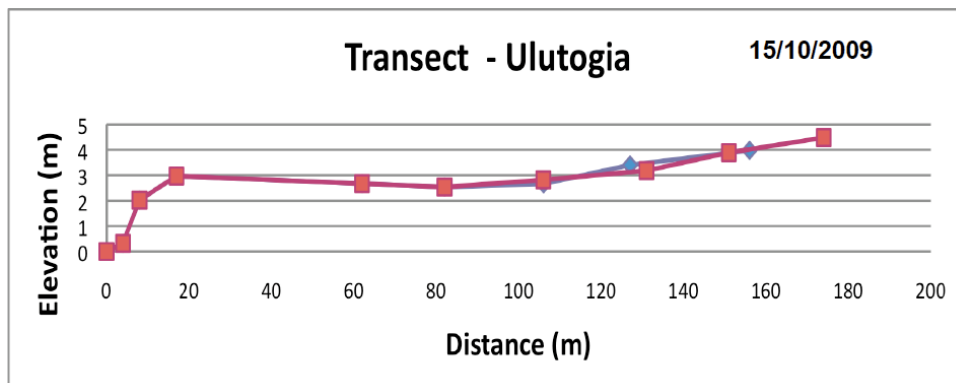
Two transects were taken at Vailoa, one of them was measured perpendicular to the coastline (blue line on Figure 21). The second transect (purple line in Figure 21) was taken parallel to the first, moving a few meters southward in respect to the first one in order to measure the furthest inundation point (174 m). Both transects have the first 6 points in common.

Figure 21: Transects 1 & 2 at Ulutogia

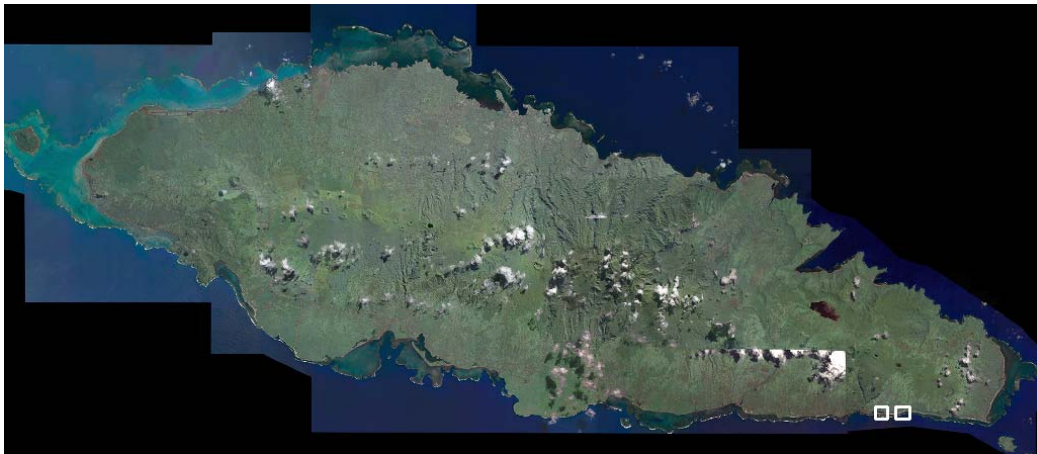
**Figure 24: Location of Saleapaga and Lepa**

Saleapaga is a small village at the Southeast Coast of Upolu seven kilometres west of Lalomanu (Figure 24). The area is fairly flat with an adjacent moderate-sloping narrow beach (Figure 25) protected by a rock seawall. Approximately 200m inland (Figure 26) from the shore is a steep slope that confines the buildings to a relatively narrow strip between the Southern Coast Road and the cliff. Before the tsunami, the area had primarily residential houses, churches, shops and a school. Most of the residential buildings were brick/masonry, some with reinforcements such as concrete beams and columns.

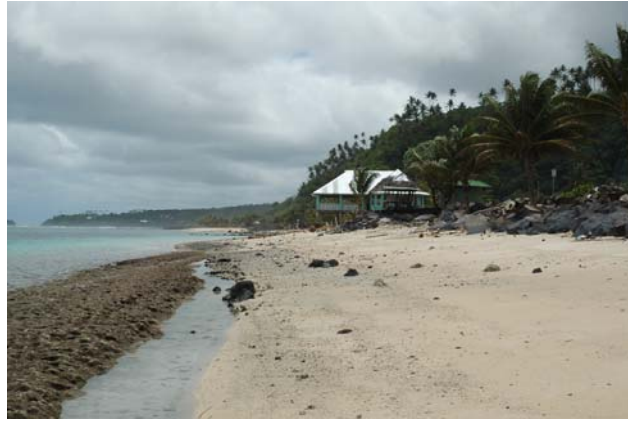
**Figure 25: Overview of beach looking east**

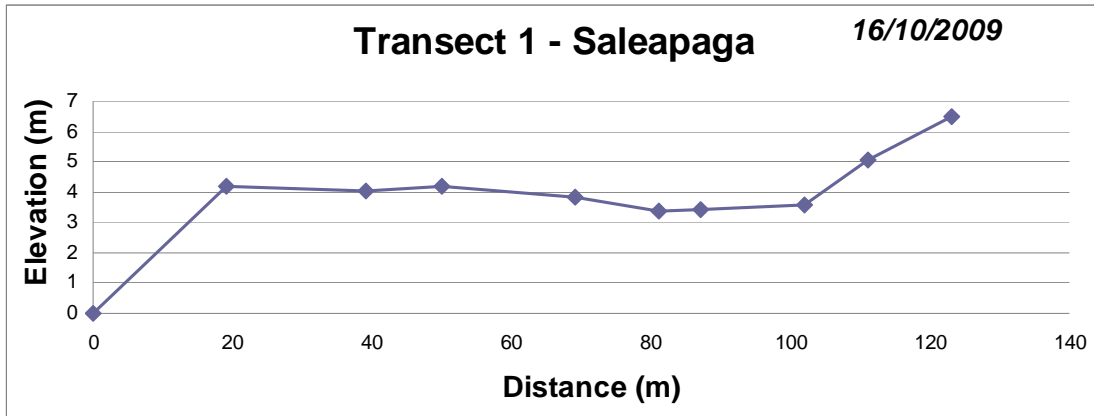
Two transects were taken at Saleapaga. The first transect is shown in Figure 29, the inundation line was measured at 123 m.

Figure 29: Transect 1 at Saleapaga

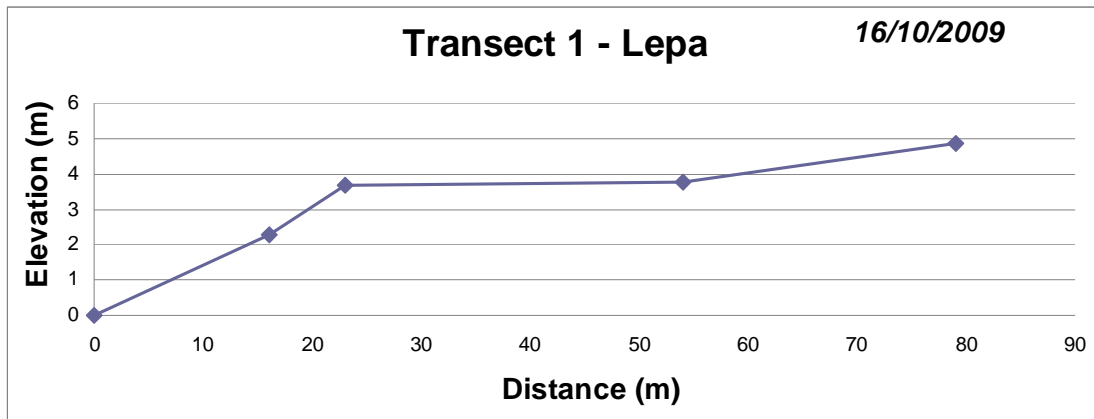
One transect was taken at the Eastern side of the river at Lepa (Figure 31), where the inland penetration reached 79 m. The slope increases 4 m along a 24 m distance inland, forming a plateau to about 54 m.

**Figure 31: Transect 1 at Lepa**

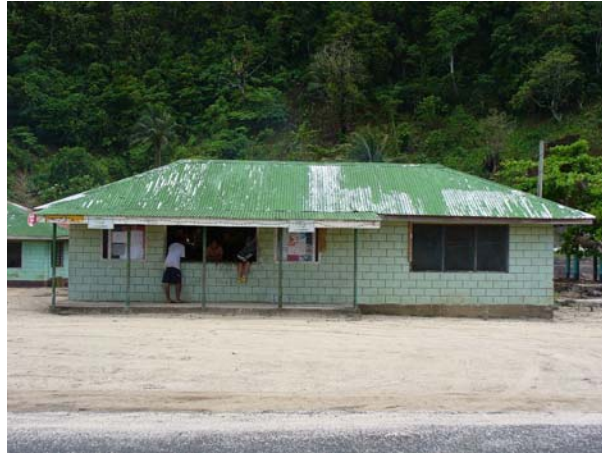
A shop owner was trapped inside the kitchen of a shop and reported a water depth of up to chest level inside. The shop only sustained minor damage and reopened pretty much straight away (Figure 32).

**Figure 32: Shop in Saleapaga**

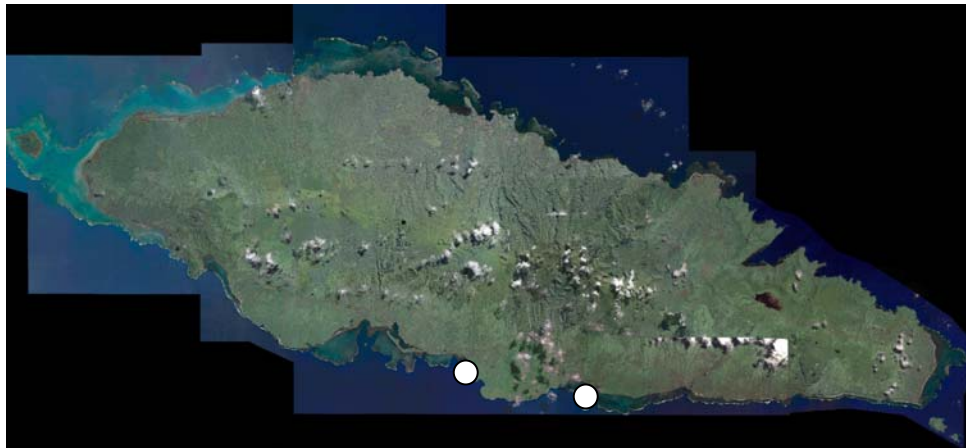
**Figure 33: Location of Coconut Beach Resort (west) and Poutasi (east)**

Coconut Beach Resort was a luxury resort with a number of buildings in close proximity to the sea. Most of the resort lies behind a 3 metre-high seawall and the resort grounds are fairly flat with moderately sloping terrain behind. Most of the resort's buildings were built with concrete-bound volcanic rocks, some with timber walls on one side.

Poutasi (Figure 33) is built on a broad plain on both sides of a river mouth with low-lying lagoon/wetland. Most of the affected residential buildings and the school were built on low ground. Approximately 300m from the sea, the ground rises on a moderately steep slope to the coastal road and beyond.

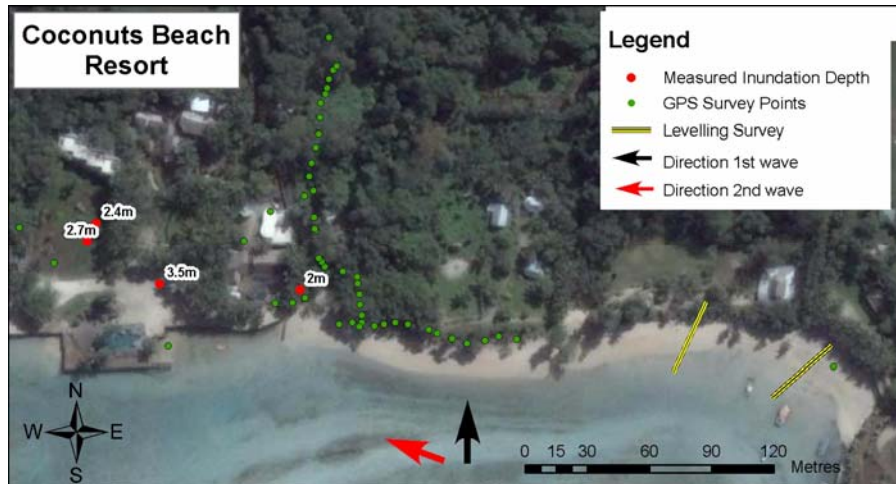
Figure 34: Survey points at Coconuts Beach Resort

Due to the distance between the two surveyed locations, two base station setups were necessary to collect accurate GPS data. For the survey of Coconuts Beach Resort, the GPS base station was setup over BM 3143 (elevation 18.2400 m) next to the road in Siumu close to the store. For the survey of Poutasi, none of the close benchmarks could be located and the base station was setup on the grounds of the high school. Measurements of tide levels will be used to calibrate the survey points vertically. Figures 34 and 35 show an overview of the surveyed area with measurement points and observed inundation depths.

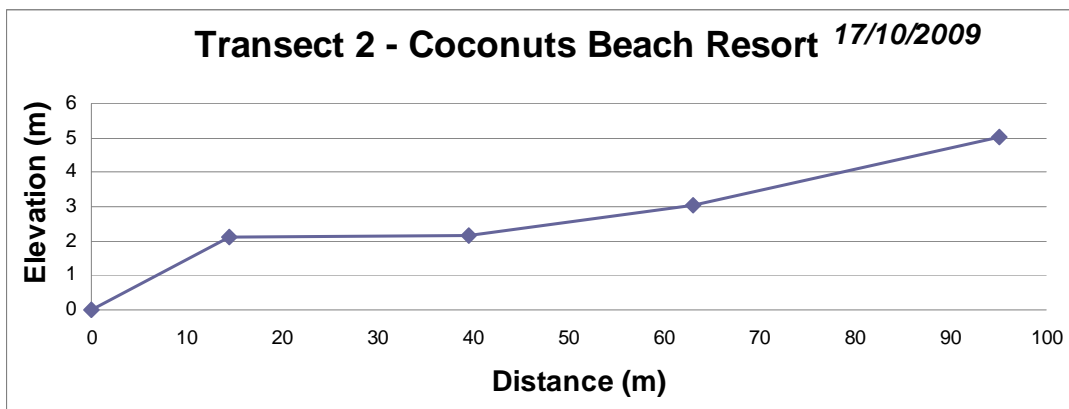
Transect 2 at Coconut Beach Resort (Figure 37) was taken west of Transect 1. In Figure 37, it can be seen that the slope still increases smoothly, with a plateau between 15 and 40 m. The inundation line was measured at 95 m inland from the shore.

**Figure 37: Transect 2 at Coconut Beach Resort**

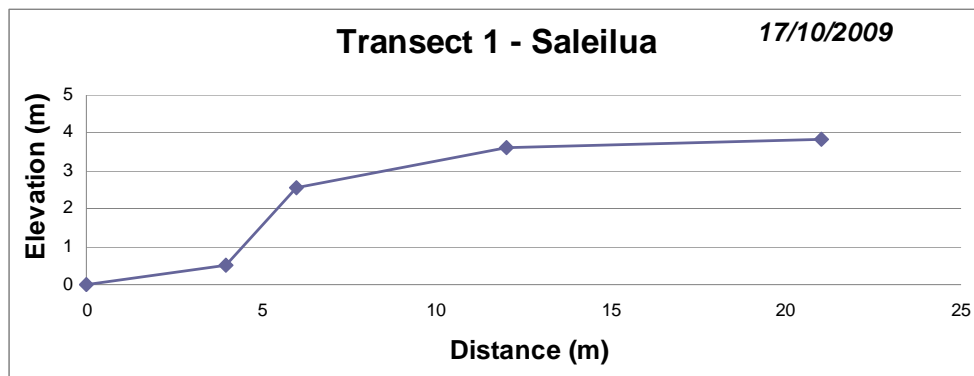
Two transects were taken at Saleilua. At this location, some information from eyewitnesses was recorded, but no watermarks or accurate descriptions could be obtained, so the inundation depth was not measured along these transects. In this village, a steep scarp (see Figures 38 and 39) close to the coastline protected the houses located on the plateau at the top of the scarp. The first transect was taken perpendicular to the coast, whereas the second transect was taken diagonally, following the probable direction of the first wave.

Figure 38: Transect 1 at Saleilua

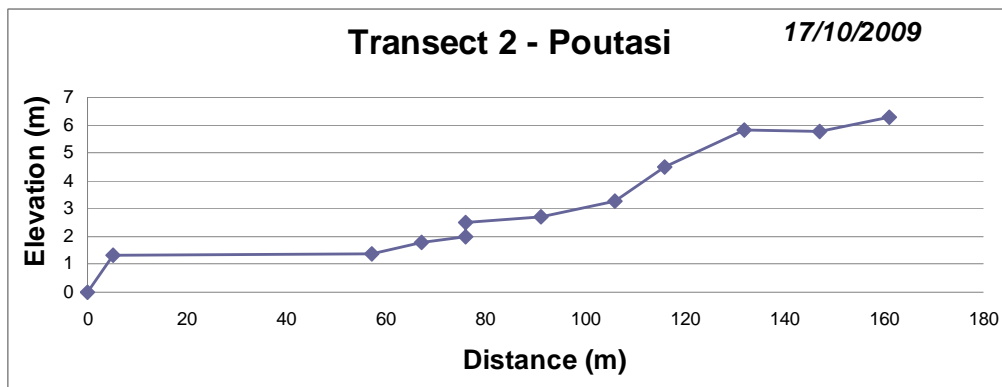
In the adjacent village of Poutasi, inundation depth could be measured along Transect 2 at a building. According to an eyewitness description and observation of damage, it reached about 3.50 m above ground level. Based on eyewitness description the inundation depth was also measured at another building where it reached about 0.8 m above ground level. The water penetration at Transect 1 was 107 m whereas at Transect 2, it was around 161 m. The two transects taken at Poutasi are shown in Figures 40 and 41.

Figure 40: Transect 1 at Poutasi

Figure 41: Transect 2 at Poutasi

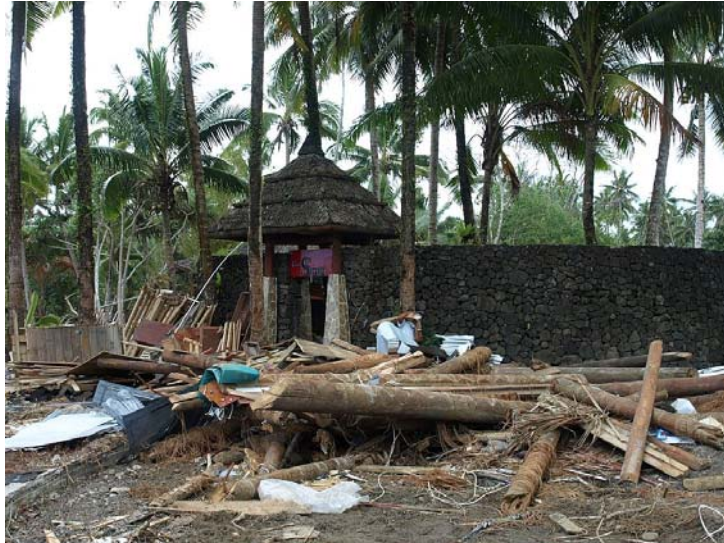
At Coconuts Beach Resort, different levels of damage were observed, ranging from complete destruction of whole buildings (reception block) to minor damage in some of the guest accommodation (Figures 42 and 43). The resort has been operating for almost 20 years at the present location, but all of the current buildings are of recent construction and less than 5 years old.

**Figure 42: Spa at Coconuts Beach Resort**

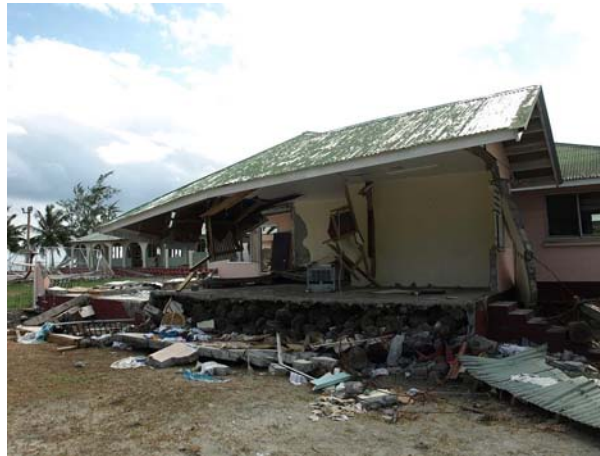
In Poutasi, a high level of damage was sustained by most buildings (Figure 44) close to the shore. The bridge over the mouth of the river was destroyed. Water entering the flat area behind the beach from the river seems to have increased the destructive power of the tsunami. Several buildings of the high school were completely destroyed and the buildings left standing sustained severe levels of damage. Most residential buildings were either completely washed away or are left in a state that is beyond repair.

**Figure 44: Damage in Poutasi**

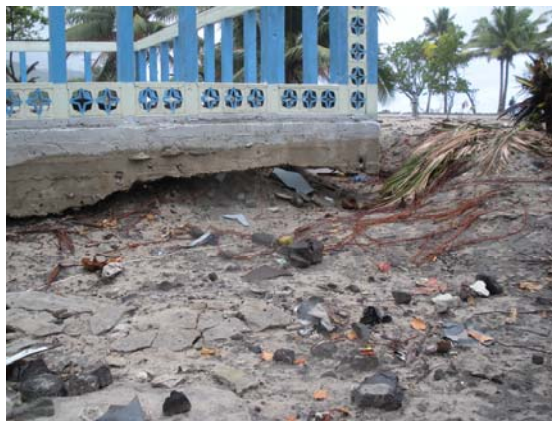
Quite a few buildings were surveyed that should have withstood the force of the tsunami but did not. This was often due to poor workmanship, poor quality of the building material or people not following the building code. As mentioned before, the most frequent example of poor workmanship were insufficient or defective foundations.

**Figure 45: Large sections of the foundation are undermined**

**RECOMMENDATION 3:** New buildings should be built on raised 'platform's approximately 1 metre higher than the surrounding landscape and on solid foundations with reinforced concrete columns

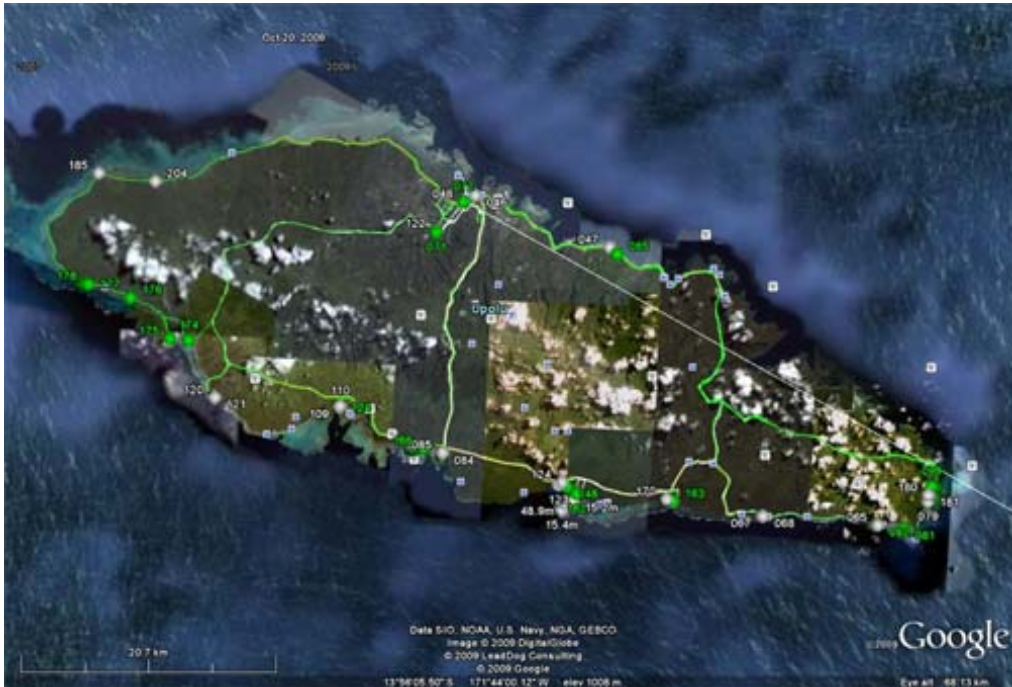
**Figure 46: Map showing areas traveled (green lines) based on hand-held GPS track logs and areas where measurements and observations were gathered (white dots).  
Base map is a Google Earth image**

We have successfully collected samples to take back to our laboratories for detailed multifaceted analyses. However, here we also report on the effects of the tsunami on the coastal geology. Figure 46 shows areas travelled and study sites on Upolu for the geology sub-group and Figure 47 shows the three sites where extensive surveys were carried out. Various types of geological data were collected including boulder measurements, trenches, samples, and water levels. Example topographic profiles in trench sites are shown in Figures 48 and 49. Table 6 is a listing of boulder measurements (incomplete) and Figure 50 is a plot showing boulder volume and long-axis orientation for the study site at Satitua. These figures, tables, and spreadsheets are not a complete listing of all data collected but are meant to show examples of the data collected during the field survey. A more complete compilation will be completed and forwarded to the ITST Samoa for transmission to the Government of Samoa at a later date.

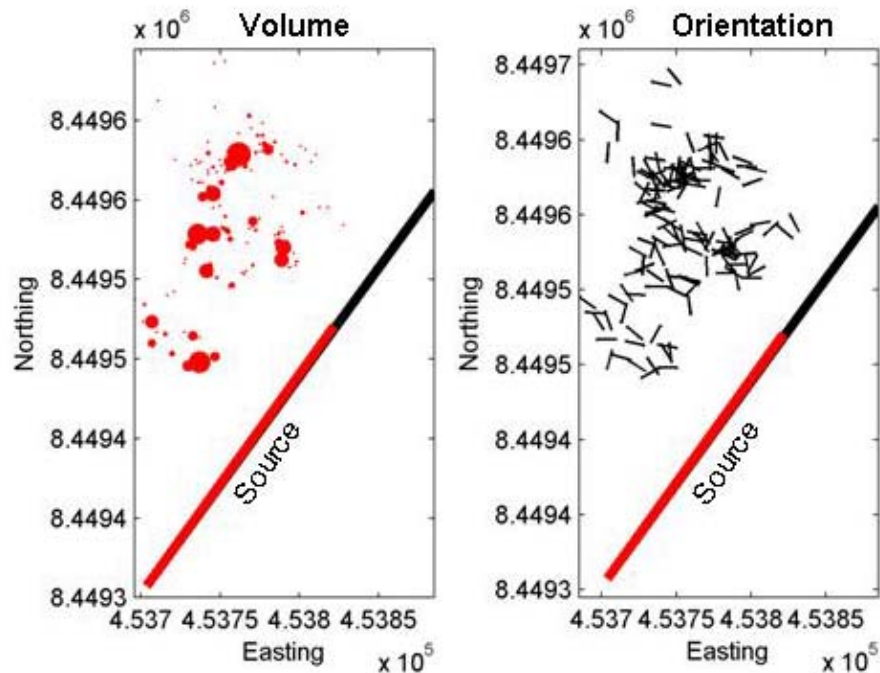
**Figure 50: Plots of relative boulder volume (red circles) and boulder long-axis orientation for the Satittoa boulder study site. The red and black lines show the shoreline orientation and revetment source of the boulders. The black line segment is a section of revetment that showed minimal damage**

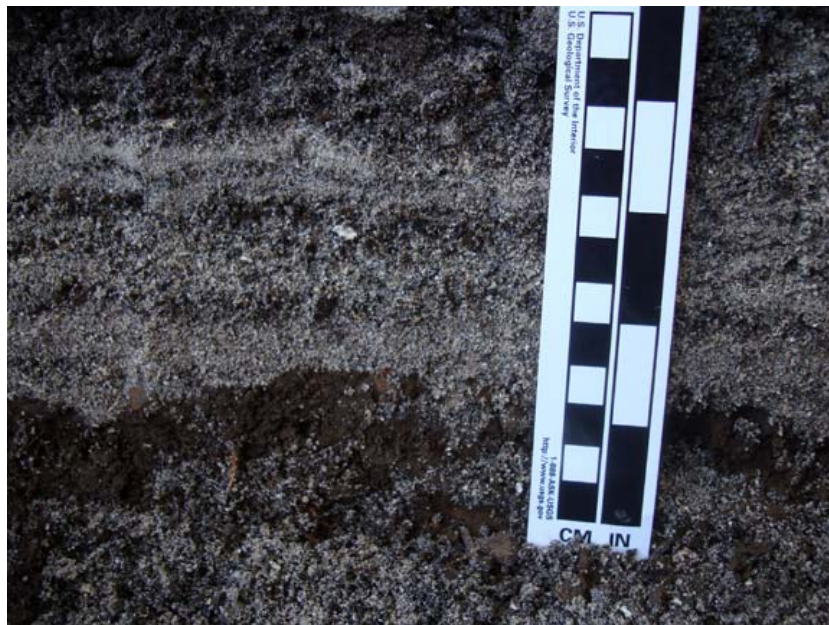
**Figure 51: Close-up of a trench face near Satitooa Village approximately 250 m from the shoreline showing, from top to bottom: tsunami mud drape, multiple alternating light and dark layers of tsunami sand, and basal pre-tsunami soil surface**
